## Preliminary Report

**Air India's B787-8 aircraft bearing registration VT-ANB  
at Ahmedabad on 12 June 2025**

Aircraft Accident Investigation Bureau

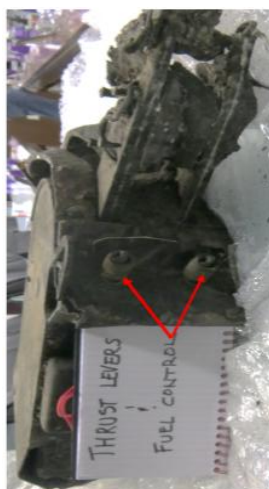
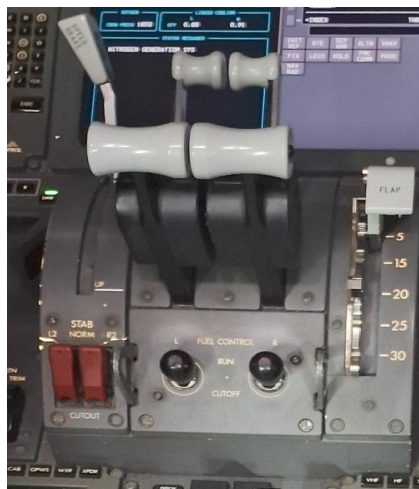
Figure 13 Thrust Lever Quadrant & Fuel Control Switch

The thrust lever quadrant sustained significant thermal damage. Both thrust levers were found near the aft (idle) position. However, the EAFR data revealed that the thrust levers remained forward (takeoff thrust) until the impact. Both fuel control switch were found in the “RUN” position. (*fig.13*) The reverser levers were bent but were in the “stowed” position. The wiring from the TO/GA switches and autothrottle disconnect switches were visible, but heavily damaged.
